Manhole Inspection Summary

Manhole # S29WW_013MH

Insp Date: **5/17/07 10:18 AM**

Location Address: **323 WYMAN PARK**

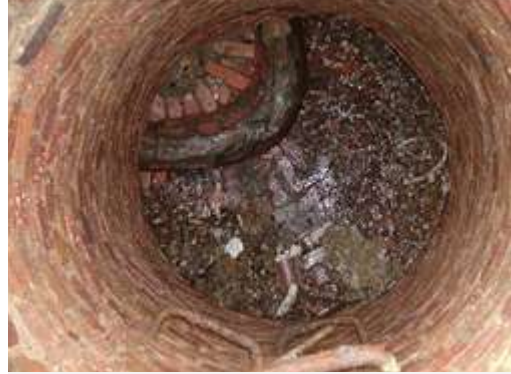
Top View

Corroded steps. Evidence of surcharge - Bench debris.

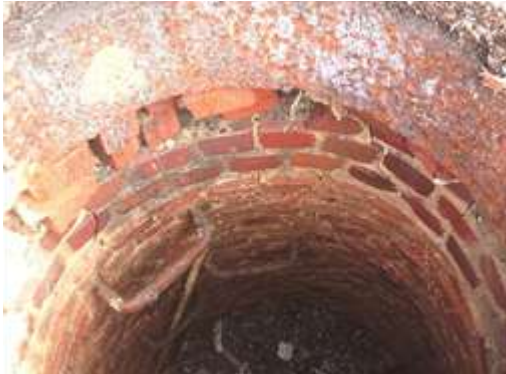
Defect

Frame leaks. Adjustment deterioration, loose brick and infiltration. Corbel and Barrel infiltration - other side.

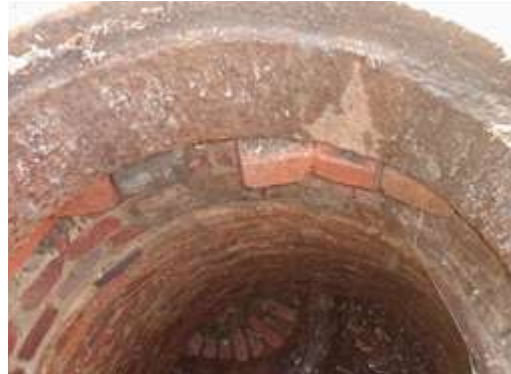
Defect

Frame leaks. Adjustment deterioration, loose brick and infiltration. Corbel and Barrel infiltration.

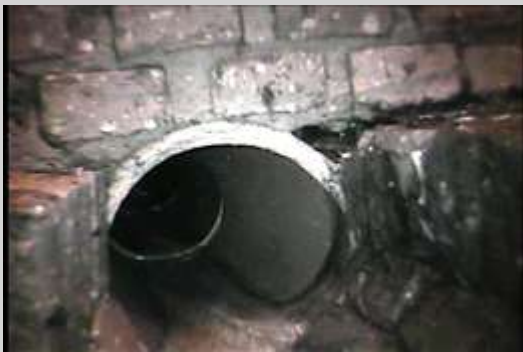
8 in. Circular Gravity Sewer Pipe Out @ 12 O'Clock

Infiltration: **None** Pipe Seal Cond: **Unknown**

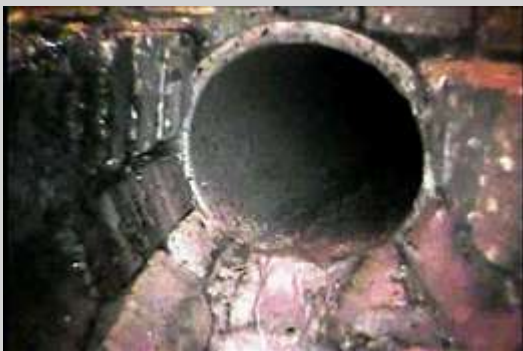
8 in. Circular Gravity Sewer Pipe In @ 9 O'Clock

Channel deterioration.

Infiltration: **Evidence** Pipe Seal Cond: **Unknown**
